Manhole Inspection Summary

Manhole # S21KK_042MH

Insp Date: **7/30/09 10:27 AM**

Location Address: **1728 NORTH AVE**

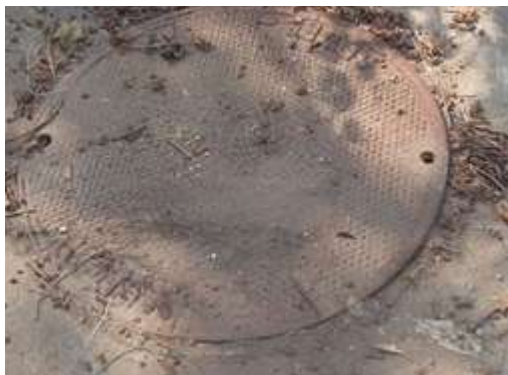
SHEETING

EVIDENCE OF INFILTRATION DUE TO SHEETING FROM ALLEY DRAINAGE

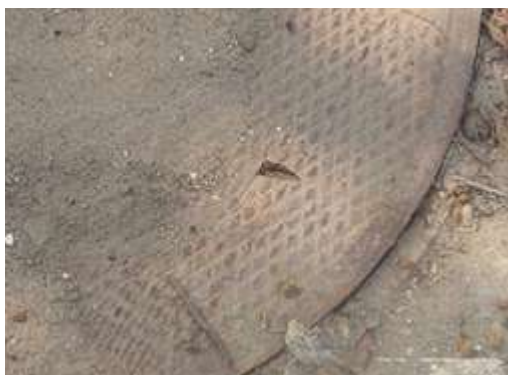
Defect 1

CRACKED LID

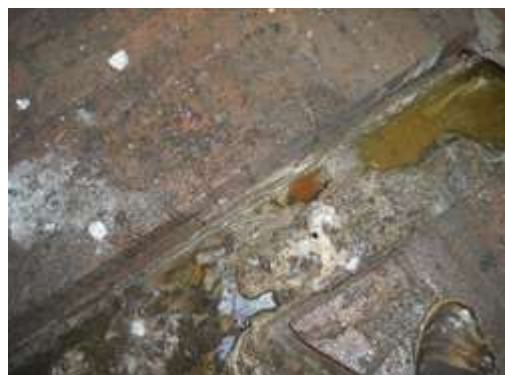
Defect 2

DEBRIS IN CHANNEL

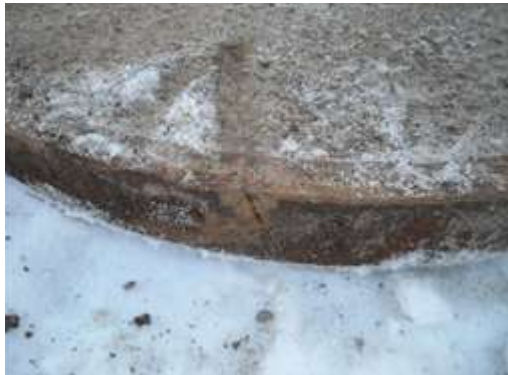
Defect 3

LID IS CRACKED

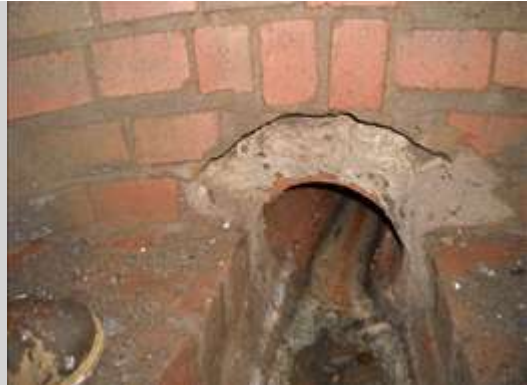
12 O'Clock Outflow

NOTE MISSING BRICKS AROUND
CONNECTION

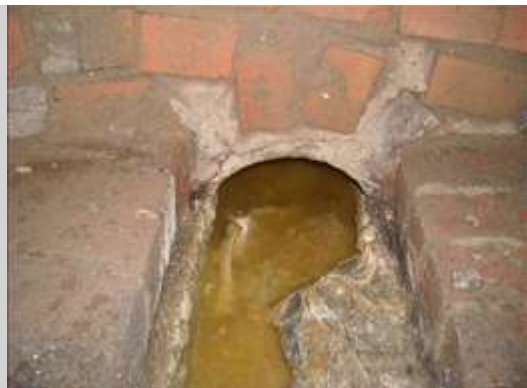
6 O'Clock Inflow

Deposits: ☐ None ☐ Mud ☒ ~~Grassy~~ ☒ Debris ☒ Grease

Silt Depth: **3** (in.) Deposits Extent: **Medium**

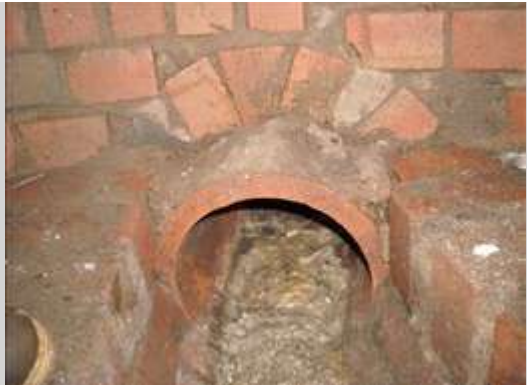
9 O'Clock Inflow

Pipe Height: **9.6** (in.) Rod and Bar (Angled)
Pipe Material: **Clay** ☐ Pipe Lined
Invert Depth: **7.57** (ft.) Flow Characteristics: **None**
Deposits: ☐ None ☐ Mud ☒ ~~Sludge~~ **Debris** ☐ Grease
Silt Depth: **2** (in.) Deposits Extent: **Light**
Infiltration: **None** Pipe Seal Cond: **Sound**
